# State of Water Quality in the Waituna Catchment

## March 2008 - 2009

• This newsletter provides an update on the current state of water quality in the Waituna catchment creeks and of the lagoon.

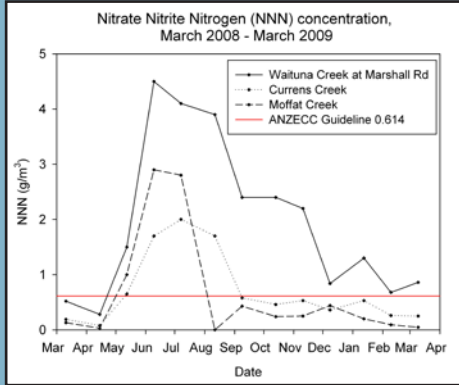
Figure 2. During March 2008 – March 2009 approximately 83% of NNN samples were worse than the guideline.

In June 2008, a nitrate spike was recorded at all creek sites (Figure 2), illustrating a considerable loss of nitrate from the catchment. The highest nitrate level was recorded in the Waituna Creek at Marshall Rd (Figure 2).

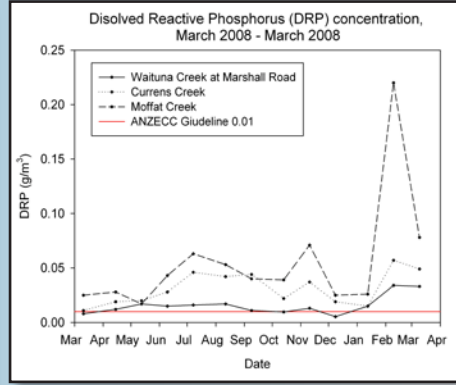
Figure 3. During March 2008 – March 2009 approximately 86% of DRP samples were worse than the guideline.

DRP concentrations in the creeks have been consistently worse than the guideline, illustrating a large loss of phosphorus from the catchment. Moffat Creek had the highest concentrations and a peak in February 2009 (Figure 3).

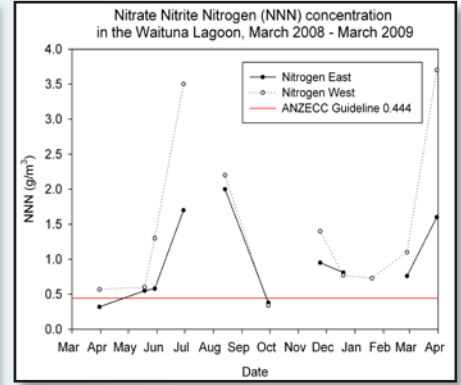
Figure 4. During Mar March 2008 – March 2009 approximately 42% of NNN samples in the lagoon were worse than the guideline.

The nitrate nitrogen concentration in the lagoon has been consistently worse than the guideline, particularly high spikes occurred in July of 2008 and March of 2009. Concentrations decreased following opening of the lagoon in August 2008. The nitrate concentration has been worse than the guideline since December 2008 (Figure 4).

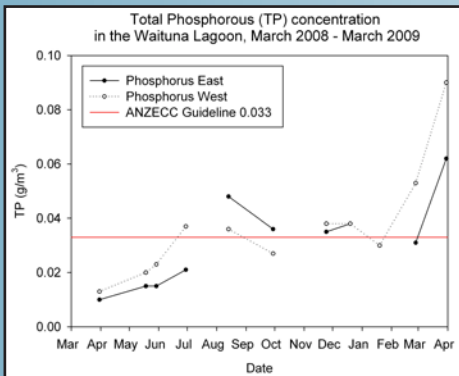
Figure 5. During March 2008 – March 2009 approximately 68% of TP samples in the lagoon were worse than the guideline.

The total phosphorus concentration in the lagoon has gradually increased over the last year (Figure 5). Concentrations decreased following the lagoon opening in August 2008 (Figure 7). TP concentrations are currently worse than the guideline (Figure 5). Increasing phosphorus concentrations are a result of both high volumes of phosphorus entering the lagoon from the creeks, and of the lagoon being open for only a short period of tidal flushing in the last 2 years.

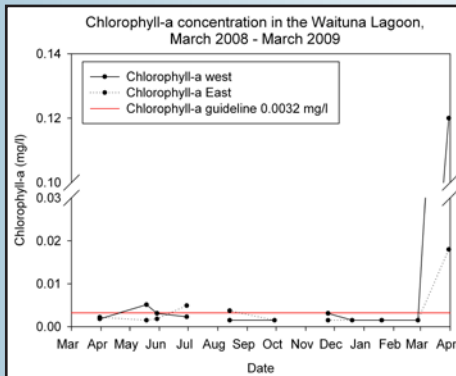
Figure 6. During March 2008 – March 2009 approximately 56% of Chlorophyll-a samples in the lagoon were worse than the guideline.

The Chlorophyll-a concentration in the lagoon was low until March 2009, when a large increase was recorded (Figure 6). The Chlorophyll-a concentration gives an indication of the amount of plant and algal growth occurring in the lagoon. Increased Chlorophyll-a concentration is likely to have occurred as a result of increasing concentrations of phosphorus and nitrogen in the lagoon. Because phosphorus is the limiting nutrient in the lagoon, it regulates plant growth.

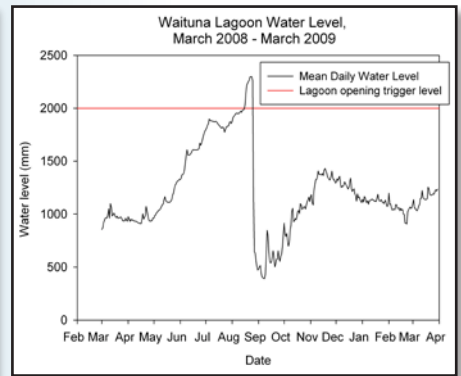
Figure 7. The lagoon water level gradually increased until it was opened in August 2008. Since the lagoon closed in September the level has gradually increased.
